**PRECIPITATION STATIC ELECTRICITY AND
SWEPT-STROKE LIGHTNING EFFECTS ON
AIRCRAFT TRANSPARENCY COATINGS**

R.C. Twomey
Douglas Aircraft Company
McDonnell Douglas Corporation
3855 Lakewood Boulevard
Long Beach, California 90846

DECEMBER 1977

TECHNICAL REPORT AFFDL-TR-77-141

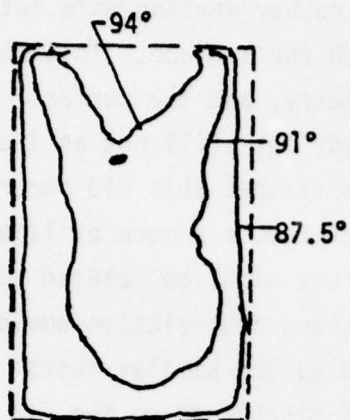
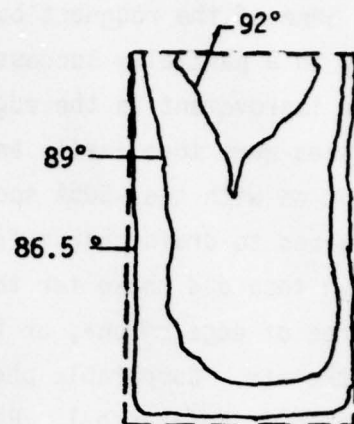
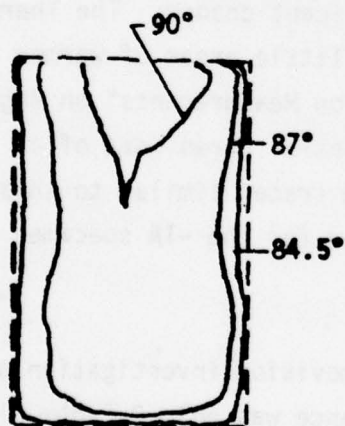
Figure 14. Isothermal Traces on
-505A Specimen After
Static Electric
Discharges.

first exposure, and second exposure thermographs are shown in Figure 14. Note that the isotherm lines on the traces do not represent the same temperature for each Thermovision run. The important, easily derived information from the traces is that no significant change in the heating pattern took place. This observation translates to the conclusion that a large number of surface flashes apparently did not induce damaging current into the gold conductive coating of the -505A specimen.

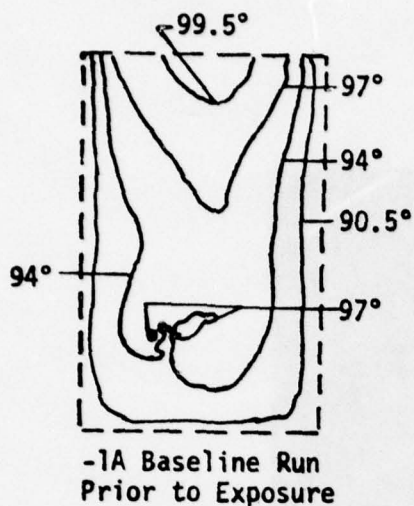
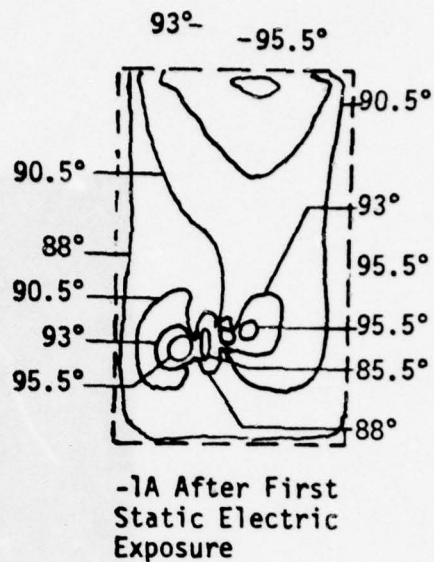
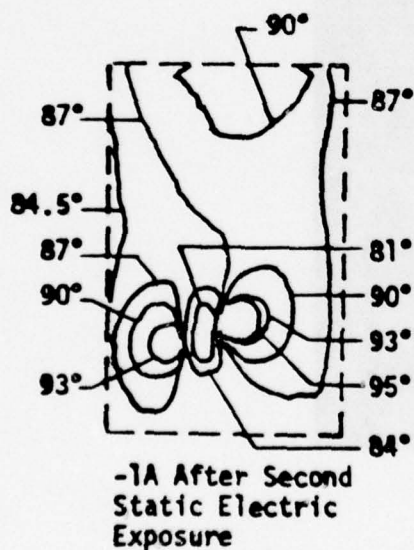
Figure 16. Isothermal Traces on -1A Specimen After Static Electric Discharge.

The visual inspection yielded no indication of damage. Resistance measurements (Table I) also indicated no significant change. The Thermovision inspection did show a change in the two little areas of warmer temperature discussed under "Initial Thermovision Measurements" on Page 23. They appeared to be more accentuated and the central cores were of a slightly higher relative temperature. Isotherm traces similar to those previously discussed for Figure 14 are presented for the -1A specimen in Figure 16.

a continuing slight deterioration in the homogeneity of the resistance coating in this area of the specimen. Figure 16 also shows the isotherm tracings for the specimen after the second static electric discharge series. Although there had been a very noticeable change in the isotherm plot between the baseline run and the last run, it is doubtful that these changes would degrade the ability of the resistive coating to perform a satisfactory anti-icing function if it were a part of an actual aircraft windshield. However, there is the unanswered question of whether the continuous cycling of heating current, as would be encountered in an actual windshield, would cause the discharge induced changes in the resistive coating to further change and develop into an unsatisfactory condition.

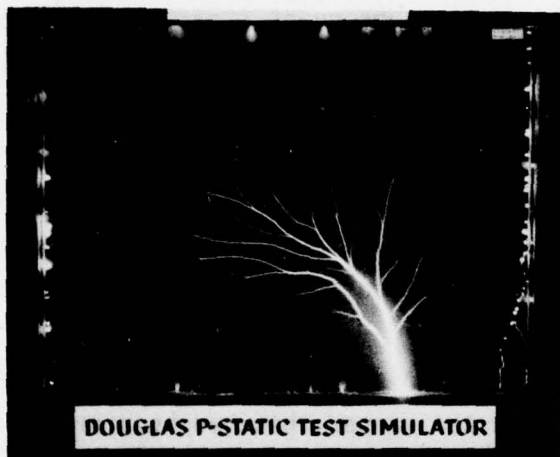
Figure 20. -1B Specimen Undergoing Static Discharge After Lightning Exposure.

Figure 20 is a photograph which shows a large oak tree discharge as well as sparking along the right and left edges adjacent to the bus bars. The bus bars are the straight vertical lines bordering the open area of the transparency. Note the forked line in the lower right corner. (This corresponds to the lower left during the Thermovision tests.) The area that was hot to the touch and bubbled during the post-exposure heating is at the lower left edge in Figure 20.

After this P-static discharge exposure the damage was very visible. The action of the internal sparking had caused the flaws in the coating and in the bus-coating interface to be colored a faint pink. Examinations of the specimen before and after this P-static exposure indicated that the static discharge did not significantly increase the extent of the previous damage, but caused a visual enhancement of the existing damage. Attempts to photograph this damage were not too successful. Figure 21 is a photograph of the lower left edge of Figure 20 as viewed from the opposite side of the specimen. The bus bar is the solid line about 0.3-inch wide along the lower part of the photo.

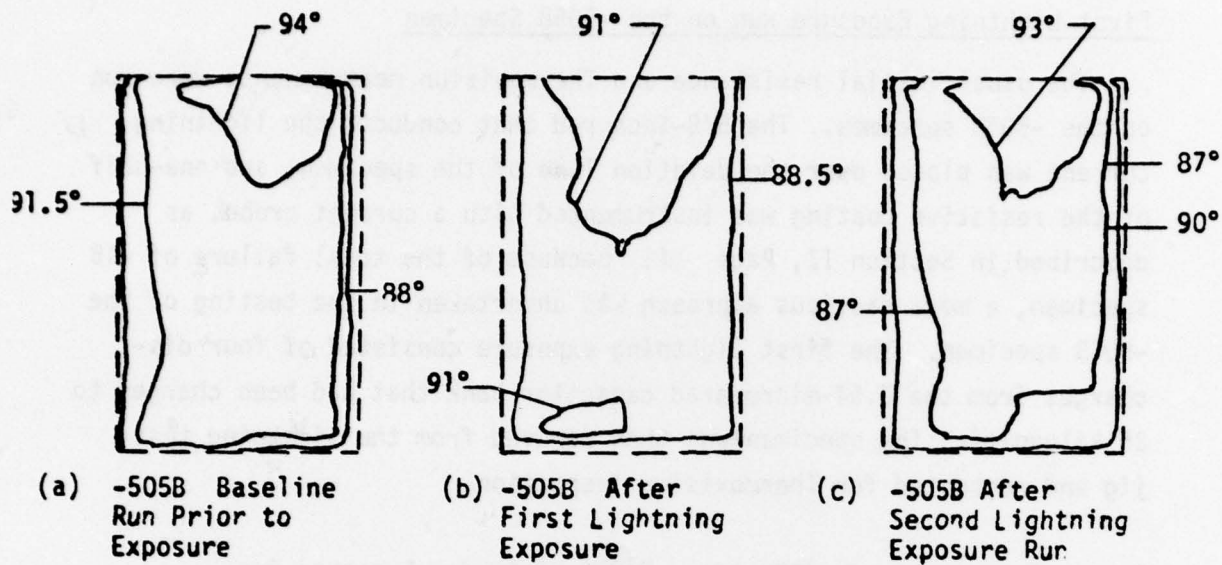
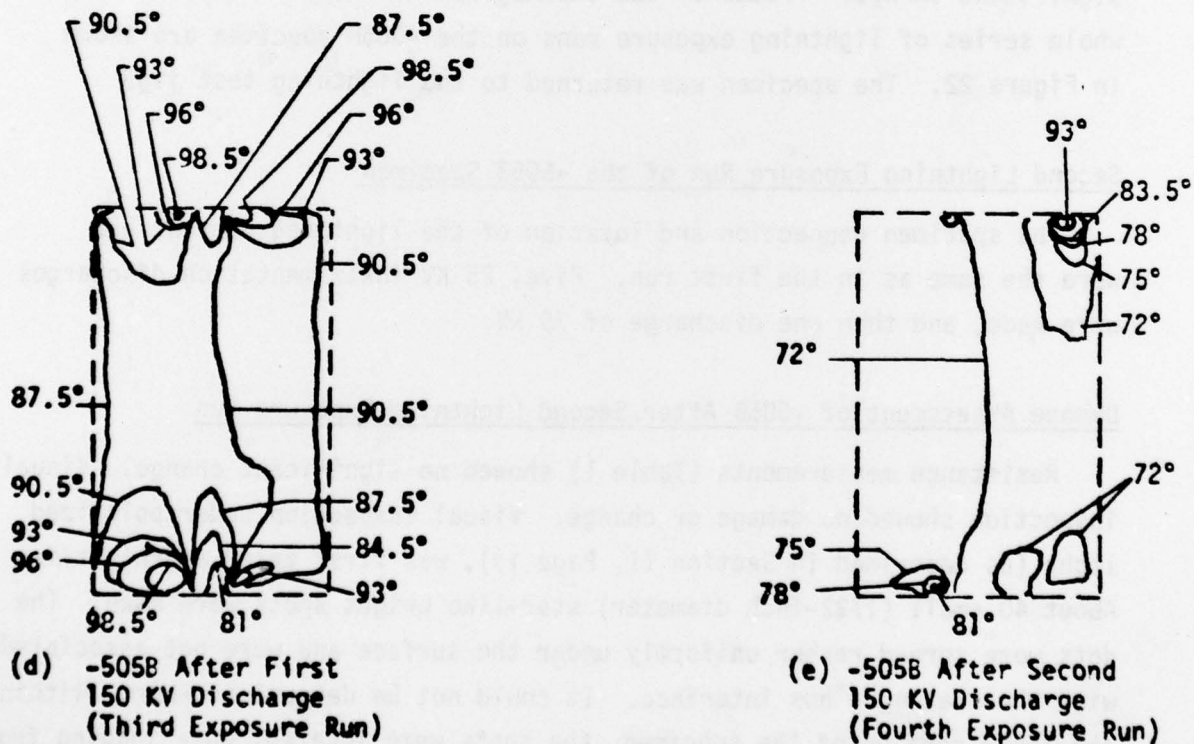
Figure 22. Isothermal Traces on -505B After Lightning Exposure.

Resistance measurements (Table 1) showed no significant change. Visual inspection showed no damage or change. Visual inspection under polarized light (as described in Section II, Page 17), was first tried at this time. About 40 small (1/32-inch diameter) star-like bright spots were seen. The dots were spread rather uniformly under the surface and were not associated with the coating - bus interface. It could not be determined where, within the inner portion of the specimen, the spots were located, but, judging from

the degree of parallax observed, the spots were probably not in the resistive coating. These spots could not be seen in unpolarized (normal) light. Their number and intensity did not seem to change as the specimen heated.

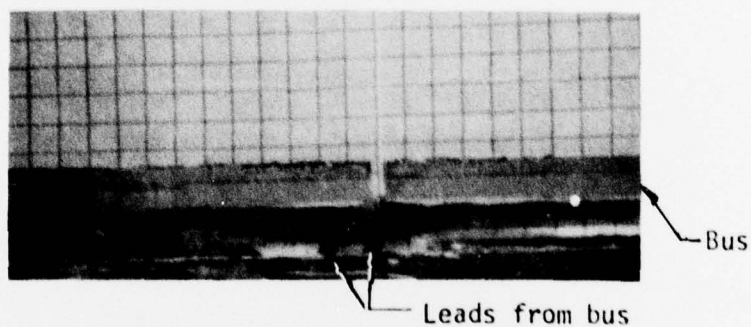
(b) Photo showing damage to coating/bus interface.
